## How Corrosion Monitoring of a Buried Pipeline using UT Sensors Post-ILI Saved >\$6MM

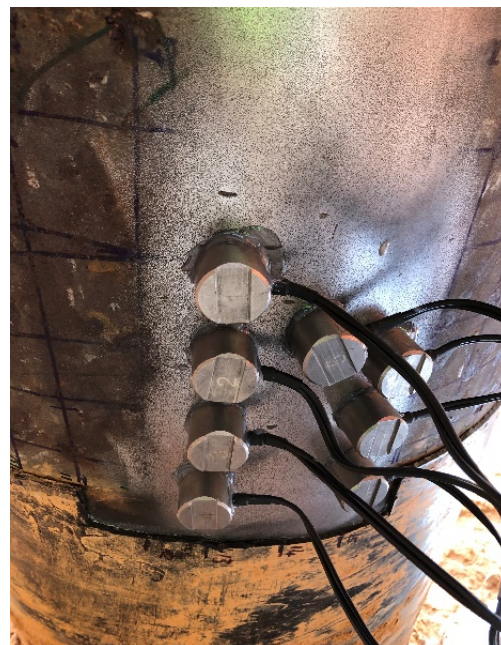
*Figure 1: Dual element sensors installed permanently on identified cluster of 'low spots' on six-o'clock position of pipeline*

**The Solution:** When comparing current ILI results to those done previously an asset owner found a cluster area which lost between 0.040"-0.089" increase in a particular area on the pipeline. The asset owner decided to install a multi-point permanent UT sensor system to monitor this section of pipe to see what corrosion rate information they could glean. During the next planned dig (direct assessment), manual inspection identified the six areas which showed

thinning clusters in a roughly 6ft. area and sensors were installed at these locations plus two sensors to 'baseline' at unaffected areas. In this case, a datalogger transmitter was used to collect data daily and every 1-2 months the readings would be manually downloaded and sent to a cloud-based back end for data analysis and trending. Alternatively a cellular transmitter could have been used whereby each reading could be wirelessly transmitted without manual download of the data. See below findings from a section of the data.

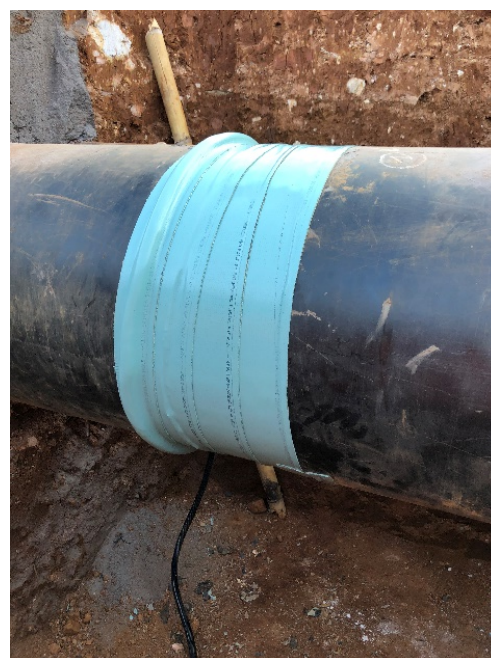
*Figure 2: Sensors covered with protective coating*
